VEHICLE MANUFACTURER NOTICE LETTER

Subject: VAPOR BUS INTERNATIONAL VOLUNTARY SAFETY RECALL

Reference: National Highway Traffic Safety Administration ("NHTSA") Campaign ID: 15E033

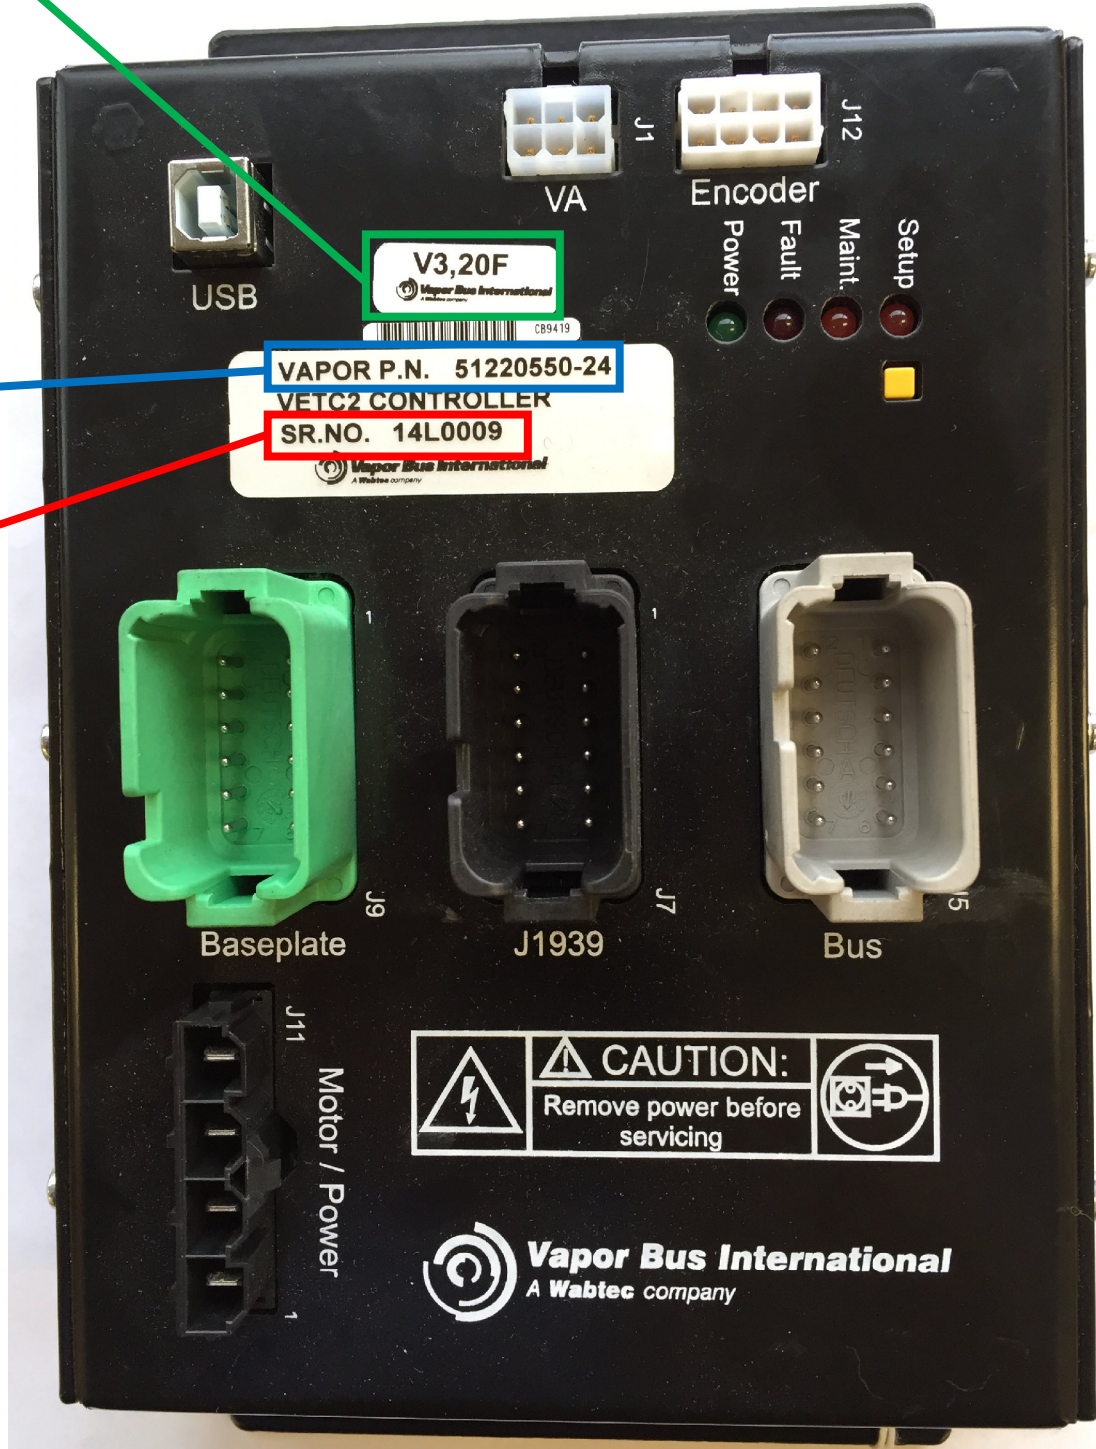
Figure 1 - ETO Controller Assembly Labeling

NEW
SOFTWARE
REVISION
LABEL
"V3.XXX"
WILL BE
APPLIED IN
THIS AREA
(NOTE:
SOFTWARE
VERSION IS
PART NUMBER
SPECIFIC)

Vapor Bus International will work with the bus manufacturer to update the ETO Controller Assembly software on all affected units free of charge. The updated version of software will provide door closed status to the bus multiplex system as soon as it transitions from the “door closed pre-load” to “door recycle open” state. All ETO Controller Assemblies that receive the updated software will be identified with a label affixed to the ETO Controller enclosure that indicates the new software revision level (see Figure 1).
